DEPARTMENT OF TRANSPORTATION**DIVISION OF ENGINEERING SERVICES**

Contract #: 04-0120F4Cty: SF/ALA Rte: 80 PM: 13.9/14.3,0.0/1.6File #: 69.28**WELDING INSPECTION REPORT****Resident Engineer:**Pursell, Gary**Address:** 333 Burma Road**City:** Oakland, CA 94607**Report No:** WIR-000849**Date Inspected:** 08-Nov-2007**Project Name:** SAS Superstructure**OSM Arrival Time:** 600**Prime Contractor:** American Bridge/Fluor Enterprises, a JV**OSM Departure Time:** 1530**Contractor:** Zhenhua Port Machinery Company, Ltd (ZPMC), Changxing Island **Location:** Shanghai, China**CWI Name:** Ye Yong Jun, Li Wen Sheng**CWI Present:** Yes No**Inspected CWI report:** Yes No N/A**Rod Oven in Use:** Yes No N/A**Electrode to specification:** Yes No N/A**Weld Procedures Followed:** Yes No N/A**Qualified Welders:** Yes No N/A**Verified Joint Fit-up:** Yes No N/A**Approved Drawings:** Yes No N/A**Approved WPS:** Yes No N/A**Delayed / Cancelled:** Yes No N/A**Bridge No:** 34-0006**Component:** CalTrans mock up**Summary of Items Observed:**

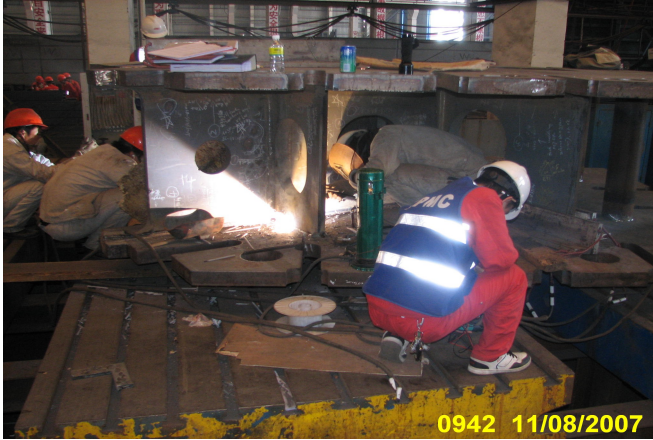
Item Description	WBS	Dwg No.	Status
1 89M Diaphragm			In Progress

Caltrans QA Inspector observed Shielded Metal Arc Welding (SMAW) in progress of fill passes on diaphragm web plate p138 to diaphragm plate SA13. The weld joint is a Partial Joint Penetration (PJP) double bevel T-joint in the 2G position. The approved welders Xu Wei #066253, Liu Guo Xuan #066279, Chen Ruyang # 066726 and Guo Dengyun were using approved welding procedure specification WPS-B-T-3312-TC-P5. Caltrans QA Inspector measured current welding parameters at approximately 242 amps, 22 volts and 135 millimeters per minute (mm/min) travel speed. Preheat and interpass temperatures were verified during welding activities. The preheat temperature prior to the start of welding measures more than 110 Celsius (230 degree Fahrenheit) but less than 232 Celsius (450 degrees Fahrenheit) during maximum interpass temperature verification. SMAW welding consumable is verified and identified as classification E9018 H4R Excalibur 4mm diameter. An electrode oven was observed by Caltrans QA Inspector in use during the welding process. ZPMC Quality Control (QC) Certified Welding Inspector (CWI) Mr. Ye Yong Jun and Bureau Veritas Inspector Mr. Li Gang were observed monitoring welding activities at the work station.

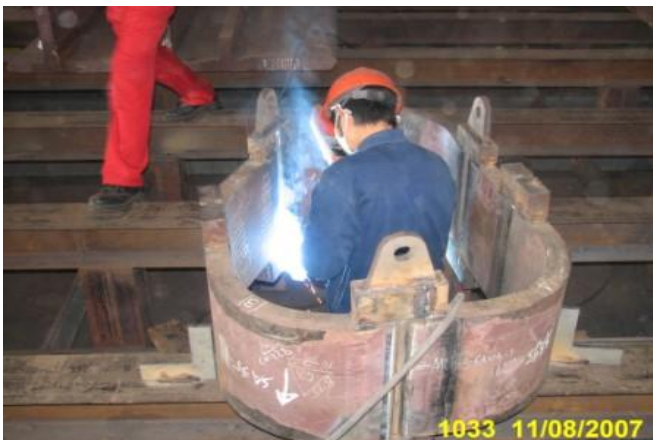
2 77M Flange Reinforcing Ring

Caltrans QA Inspector observed Flux Cored Arc Welding (FCAW) in progress of fill passes on SA274 Flange Reinforcement Ring splice weld of plate's p1086 to p1082. The weld joint is a Complete Joint Penetration (CJP) double bevel butt-joint in the 3G position. The approved welder Wang Bing #048696 was using approved welding procedure specification WPS-B-T-2233-B-U3-F. Caltrans QA Inspector measured current welding parameters at approximately 202 amps and 25.6 volts and 110 millimeters per minute (mm/min) travel speed. Preheat and interpass temperatures were verified during welding activities. The preheat temperature prior to the start of welding measures more than 110 Celsius (230 degree Fahrenheit) but less than 232 Celsius (450 degrees Fahrenheit) during maximum interpass temperature verification. FCAW welding consumable is verified and identified as Supercored 71H, classification E71T-1, diameter 1.4 mm (.055 inches). ZPMC Quality Control (QC) Certified Welding Inspector (CWI) Mr. Ye Yong Jun and Bureau Veritas Inspector Mr. Li Wen Sheng were observed monitoring welding activities at the work station.
